**Agreement No. CE 30/2018 (EP)
Environmental Team for Kai Tak Sports Park –
Design and Construction**

Monthly EM&A Report for June 2024

July 2024

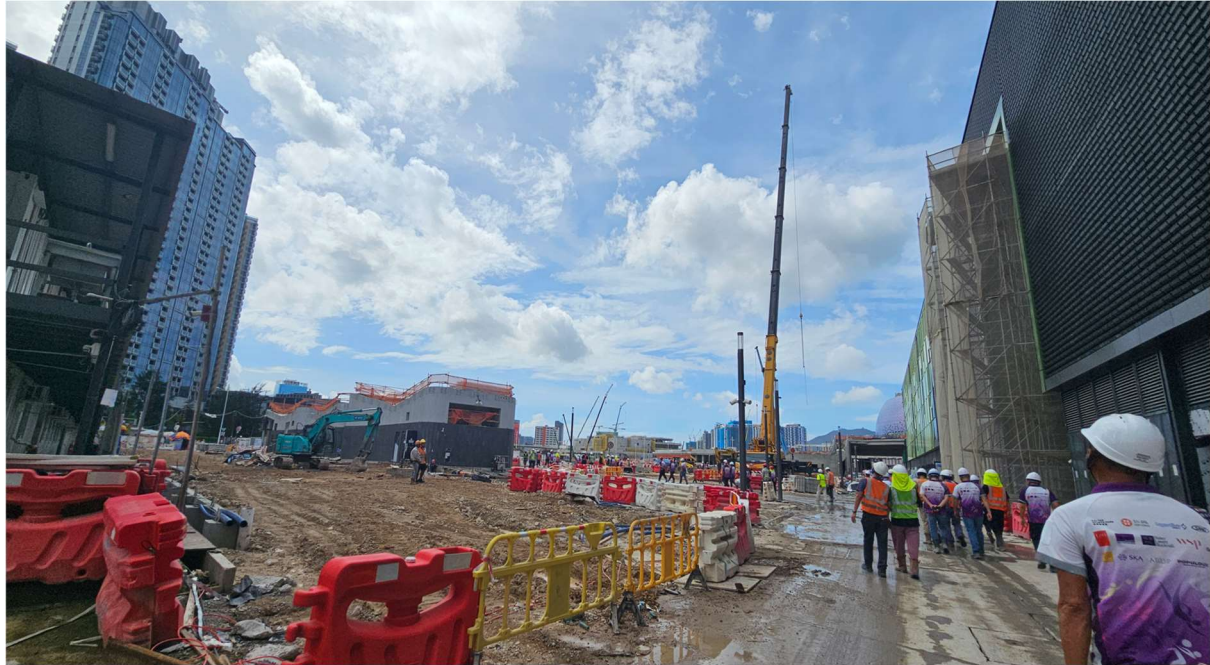
Photo 1: Regular site inspection carried out for checking dust mitigation measure on site. (25 June 2024)

RECOMMENDATIONS / MITIGATION MEASURES / ACTIONS			
Environmental mitigation measures have been maintained as follow:			
1. Covering has been provided for stockpile on site. (Photo 2)			
2. Water spraying truck has been provided on haul road to maintain wet surface. (Photo 3)			
3. Water misting cannon has been provided for dust suppression on site. (Photo 4)			
4. Implementation of construction dust mitigation measures recommended in EIA's Environmental Mitigation Implementation Schedule.			
Prepared by:	Sunny Chan	Title:	Environmental Team Leader
Signature:

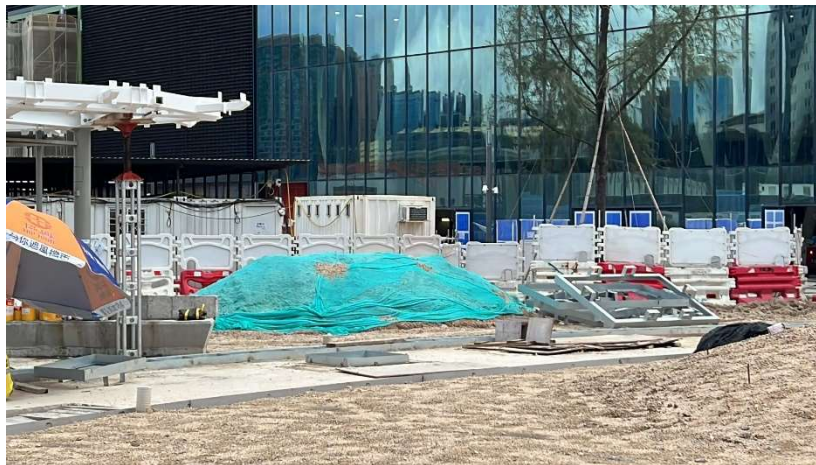
Photo 2: Covering sheet has been provided for stockpile on site.

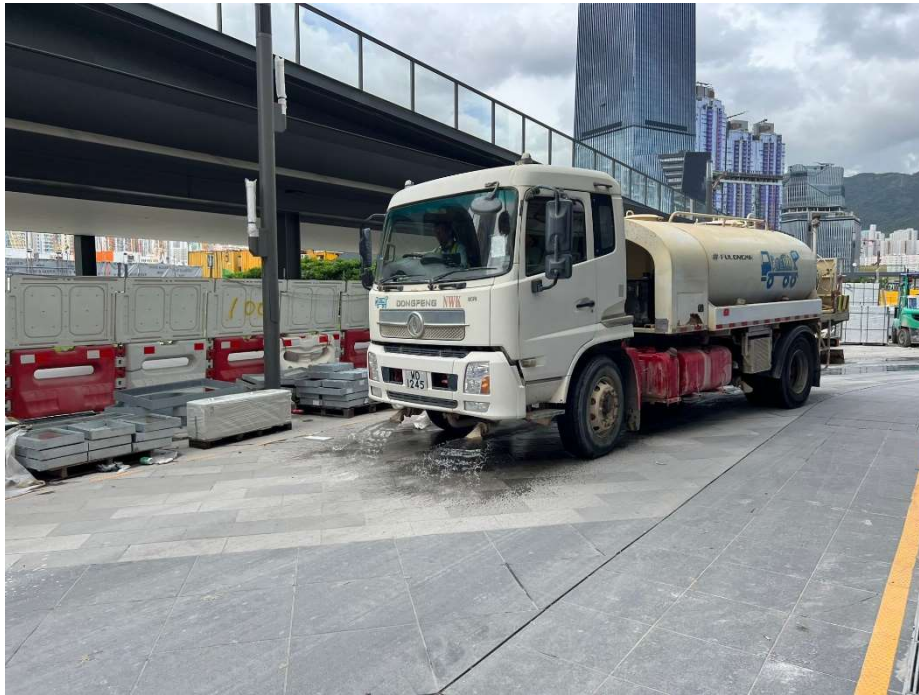
Photo 2: Water spraying truck has been provided on haul road to maintain wet surface.

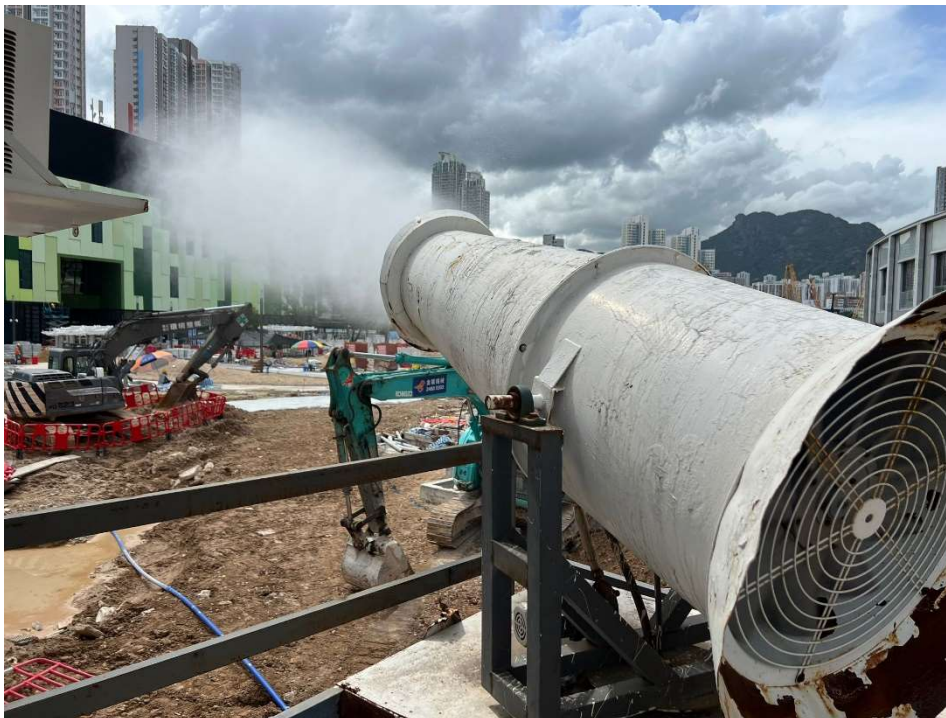
Photo 4: Water misting cannon has been provided for dust suppression on site.

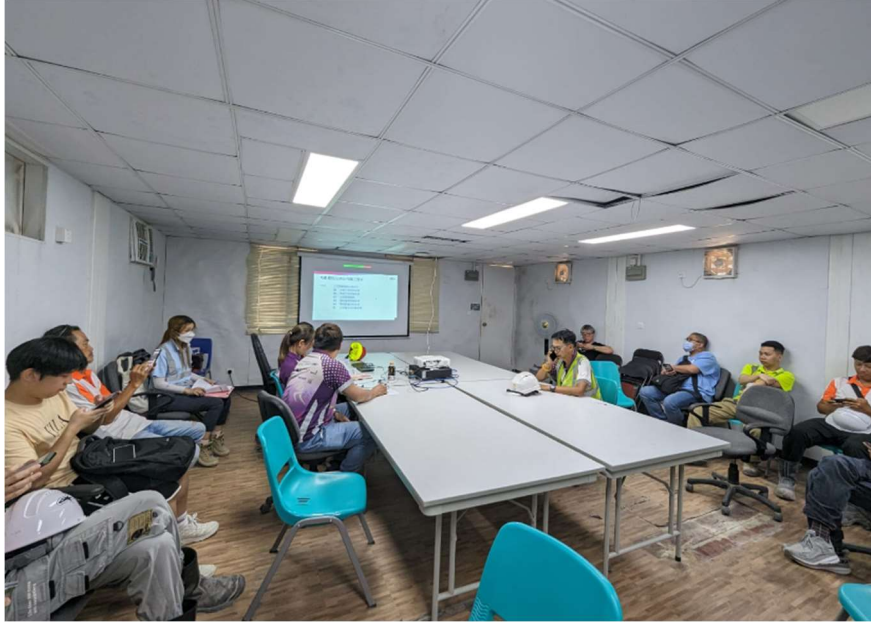
Photo 1: Subcontractors had been reminded to finish the light testing at night as early as possible to minimize the nuisance to the residents.

RECOMMENDATIONS / MITIGATION MEASURES / ACTIONS			
Environmental mitigation measures have been maintained as follow:			
1. Subcontractors had been reminded to finish the light testing at night as early as possible to minimize the nuisance to the residents. (Photo 1)
