### Agreement No. CE 30/2018 (EP) Environmental Team for Kai Tak Sports Park – Design and Construction

Monthly EM&A Report for May 2024

### Kai Tak Sports Park - Investigation

Document/Plan to be Certified/ Verified: Monthly EM&A Report No. 62 (May 2024)

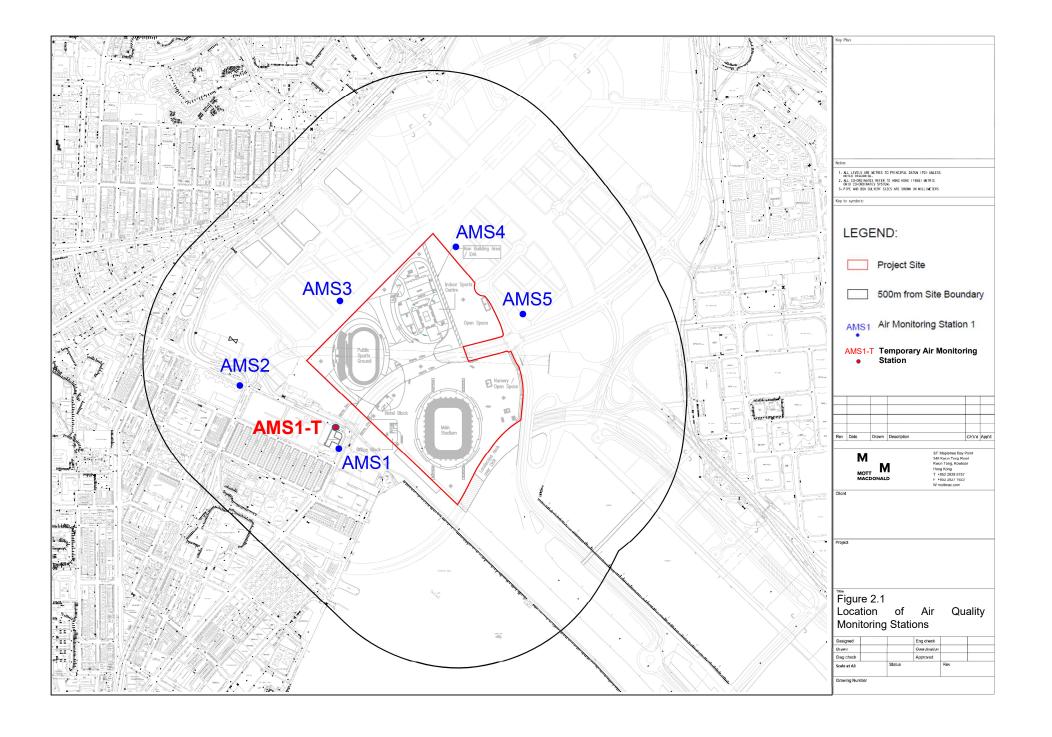
6 Conclusions	19
6.1 Conclusions	19
<u>Figures</u>	
Figure 2.1: Location of Air Quality Monitoring Stations	
Figure 3.1: Location of Noise Monitoring Stations	
Appendices	
Appendix A. Project Organization for Environmental Works	
Appendix B. Location of Works Areas	
Appendix C. Construction Programme	
Appendix D. Event and Action Plan	
Appendix E. Environmental Site Inspection and Monitoring Schedule	
Appendix F. Calibration Certificates	
Appendix G. Monitoring Data and Graphical Plots (Air Quality and Noise)	
Appendix H. Wind Data	
Appendix I. Waste Flow Table	
Appendix J. Environmental Licences and Permits	
Appendix K. Environmental Mitigation Measures Implementation Status	
Appendix L. Statistics on Environmental Complaints, Notification of Summons and	
Successful Prosecutions	
Tables	
Table 1.1: Contact Information of Key Personnel	5
Table 2.1: Air Quality Monitoring Parameters, Frequency and Duration	7
Table 2.2: Construction Dust Monitoring Locations	7

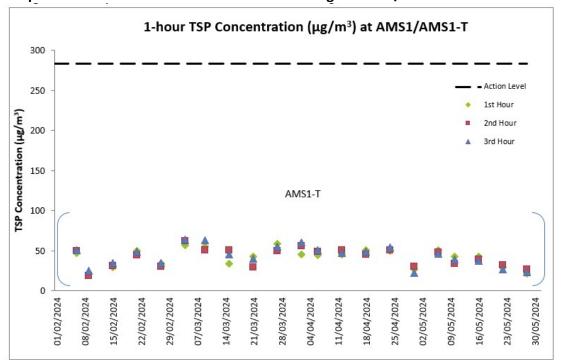
Graphical Presentation for 1-hour TSP Monitoring at AMS1/AMS1-T

<sup>\*</sup> During the reporting period, monitoring station AMS1 was no longer open for impact monitoring from 1 September 2022, due to the relocation of the Hong Kong Society for the Blind Workshop. Temporary air quality monitoring station, AMS1-T was used to conduct dust monitoring in September 2022. Details of temporary alternative monitoring locations are presented in Temporary Alternative Proposal for Monitoring Station as proposed by ET and agreed by IEC dated 6 January 2021.

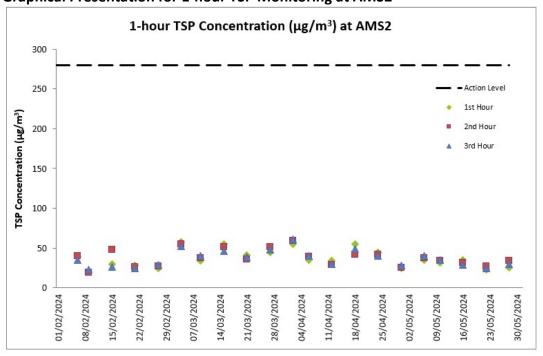
### **Graphical Presentation for 1-hour TSP Monitoring at AMS2**

Date	Start Time	Finish Time	Weather	Wind Speed (m/s)	Wind Direction (deg)	1-hour TSP (μg/m³)
06-May-24	9:02	10:02	Sunny	2.5	157	35
06-May-24	10:02	11:02	Sunny	2.5	151	37
06-May-24	11:02	12:02	Sunny	1.7	147	40
10-May-24	8:50	9:50	Cloudy	5.0	121	31
10-May-24	9:50	10:50	Cloudy	5.3	111	34
10-May-24	10:50	11:50	Cloudy	5.3	118	35
16-May-24	8:45	9:45	Sunny	6.9	115	35
16-May-24	9:45	10:45	Sunny	7.8	118	31
16-May-24	10:45	11:45	Sunny	7.5	111	29
22-May-24	8:47	9:47	Cloudy	1.4	176	23
22-May-24	9:47	10:47	Cloudy	0.8	160	27
22-May-24	10:47	11:47	Cloudy	1.1	167	24
28-May-24	8:49	9:49	Cloudy	0.3	164	25
28-May-24	9:49	10:49	Cloudy	2.5	154	34
28-May-24	10:49	11:49	Cloudy	0.0	variable	30

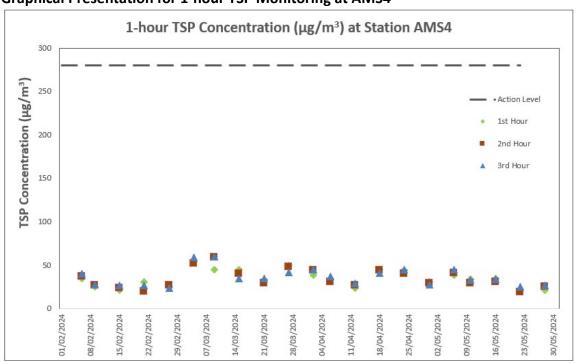
### **Graphical Presentation for 1-hour TSP Monitoring at AMS4**

Date	Start Time	Finish Time	Weather	Wind Speed (m/s)	Wind Direction (deg)	1-hour TSP (μg/m³)
06-May-24	10:40	11:40	Sunny	2.2	154	39
06-May-24	11:40	12:40	Sunny	2.5	151	41
06-May-24	12:40	13:40	Sunny	1.9	147	45
10-May-24	9:21	10:21	Cloudy	5.0	115	34
10-May-24	10:21	11:21	Cloudy	5.0	107	29
10-May-24	11:21	12:21	Cloudy	5.6	125	33
16-May-24	10:22	11:22	Sunny	7.5	112	35
16-May-24	11:22	12:22	Sunny	7.5	124	31
16-May-24	12:22	13:22	Sunny	5.8	108	34
22-May-24	10:21	11:21	Cloudy	1.1	172	21
22-May-24	11:21	12:21	Cloudy	1.7	168	19
22-May-24	12:21	13:21	Cloudy	1.9	162	25
28-May-24	10:27	11:27	Cloudy	0.8	175	21
28-May-24	11:27	12:27	Cloudy	0.6	177	25
28-May-24	12:27	13:27	Cloudy	1.9	170	27

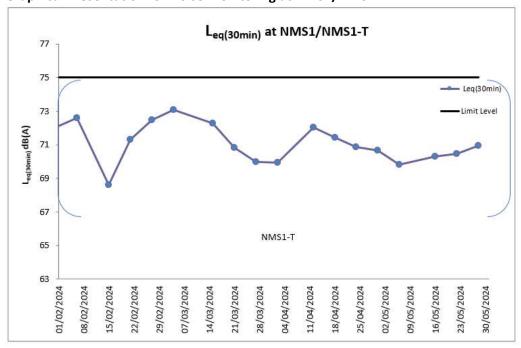
**Graphical Presentation for Noise Monitoring at NMS1/NMS1-T**

<sup>\*</sup> During the reporting period, monitoring station NMS1 was no longer open for impact monitoring from 1 September 2022, due to relocation of the Hong Kong Society for the Blind Workshop. Temporary noise monitoring station, NMS1-T was used to conduct noise monitoring in September 2022. Details of temporary alternative monitoring locations are presented in Temporary Alternative Proposal for Monitoring Station as proposed by ET and agreed by IEC dated 6 January 2021.

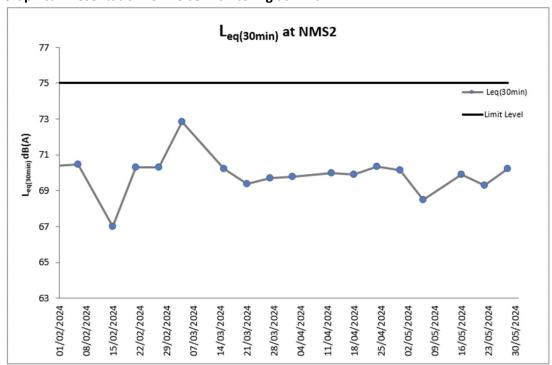
### **Graphical Presentation for Noise Monitoring at NMS2**

Date	Time	Weather	L <sub>eq(5min)</sub>	L <sub>10</sub>	L <sub>90</sub>	Measured L <sub>eq(30min)</sub>
06-May-24	09:05	Cloudy	68.4	71.0	65.2	
06-May-24	09:10	Cloudy	68.3	70.5	64.7	
06-May-24	09:15	Cloudy	68.0	70.7	63.9	68.5
06-May-24	09:20	Cloudy	68.5	71.1	64.8	00.5
06-May-24	09:25	Cloudy	69.0	72.4	63.8	
06-May-24	09:30	Cloudy	68.7	71.9	64.1	
16-May-24	08:48	Sunny	68.9	71.0	65.3	
16-May-24	08:53	Sunny	69.1	73.2	66.4	
16-May-24	08:58	Sunny	69.8	72.5	66.8	69.9
16-May-24	09:03	Sunny	70.6	74.7	67.0	09.9
16-May-24	09:08	Sunny	71.4	74.9	67.7	
16-May-24	09:13	Sunny	69.0	72.4	66.4	
22-May-24	08:50	Cloudy	68.9	71.0	65.1	
22-May-24	08:55	Cloudy	69.1	72.2	66.4	
22-May-24	09:00	Cloudy	69.7	72.3	66.6	69.3
22-May-24	09:05	Cloudy	68.5	71.9	65.8	09.5
22-May-24	09:10	Cloudy	70.4	73.7	67.0	
22-May-24	09:15	Cloudy	69.0	72.6	65.9	
28-May-24	08:52	Cloudy	68.9	71.4	65.3	
28-May-24	08:57	Cloudy	69.5	72.2	66.6	
28-May-24	09:02	Cloudy	70.1	73.0	66.6	70.2

28-May-24	09:07	Cloudy	71.7	74.8	67.9	70.2
28-May-24	09:12	Cloudy	69.6	72.7	65.1	
28-May-24	09:17	Cloudy	71.0	74.6	67.0

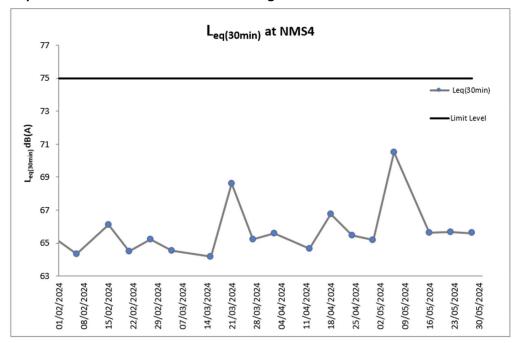
### **Graphical Presentation for Noise Monitoring at NMS4**

Date	Time	Weather	L <sub>eq(5min)</sub>	L <sub>10</sub>	L <sub>90</sub>	Measured L <sub>eq(30min)</sub>
06-May-24	09:05	Sunny	69.2	69.8	66.4	
06-May-24	09:10	Sunny	67.9	69.5	64.9	
06-May-24	09:15	Sunny	70.2	72.1	66.5	70.5
06-May-24	09:20	Sunny	71.4	73.7	67.2	70.5
06-May-24	09:25	Sunny	72.0	73.6	68.9	
06-May-24	09:30	Sunny	71.1	72.9	68.3	
16-May-24	08:48	Sunny	64.0	66.5	62.9	
16-May-24	08:53	Sunny	65.6	67.6	63.4	
16-May-24	08:58	Sunny	65.3	67.2	63.7	65.6
16-May-24	09:03	Sunny	66.9	68.8	64.1	05.0
16-May-24	09:08	Sunny	66.1	68.0	64.1	
16-May-24	09:13	Sunny	65.4	67.5	63.2	
22-May-24	08:50	Cloudy	64.0	66.6	62.5	
22-May-24	08:55	Cloudy	65.7	67.4	63.8	
22-May-24	09:00	Cloudy	66.3	68.9	64.0	65.7
22-May-24	09:05	Cloudy	66.9	68.2	64.7	05.7
22-May-24	09:10	Cloudy	65.1	67.0	63.0	
22-May-24	09:15	Cloudy	65.4	67.5	63.4	
28-May-24	08:52	Cloudy	64.0	66.6	62.5	
28-May-24	08:57	Cloudy	66.7	68.4	64.8	
28-May-24	09:02	Cloudy	65.3	67.9	63.0	CF C

28-May-24	09:07	Cloudy	65.8	67.2	63.7	65.6
28-May-24	09:12	Cloudy	64.1	66.0	62.6	
28-May-24	09:17	Cloudy	66.9	68.4	64.4
