**Agreement No. CE 30/2018 (EP)  
Environmental Team for Kai Tak Sports Park –  
Design and Construction**

Monthly EM&A Report for September 2024

October 2024

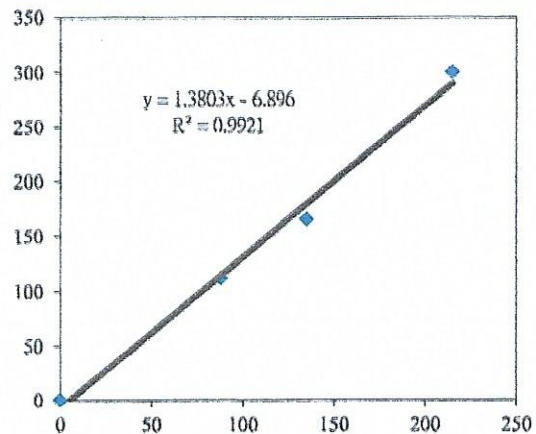
Linear Regression of Y or X

Slope (K-factor): 1.3803(µg/m³)/CPM  
Correlation Coefficient (R): 0.9960  
Date of Issue: 15-Dec-2023

- 1. Strong Correlation (>0.8)
- 2. Factor 1.3803 (µg/m³)/CPM should be applied for TSP monitoring

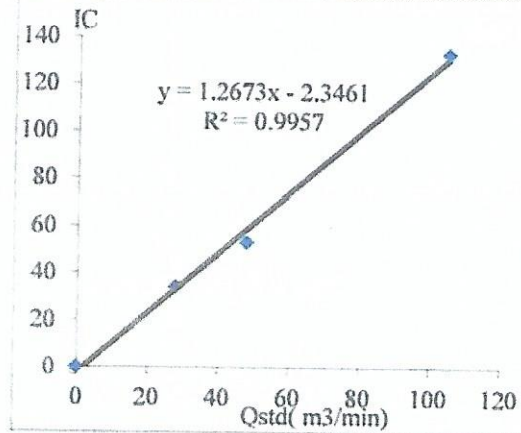
Linear Regression of Y or X

Slope (K-factor): 1.2673(µg/m³)/CPM  
Correlation Coefficient (R): 0.9978  
Date of Issue: 19-May-2024

- 1. Strong Correlation (>0.8)
- 2. Factor 1.2673(µg/m³)/CPM should be applied for TSP monitoring

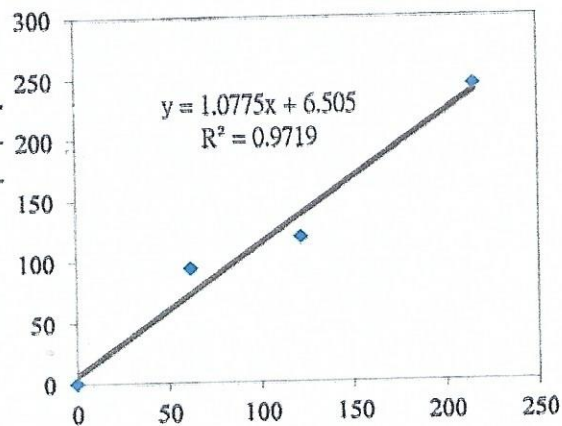
Linear Regression of Y or X

Slope (K-factor): 1.0775(µg/m³)/CPM  
Correlation Coefficient (R): 0.9859  
Date of Issue: 5-Apr-2024

1. Strong Correlation (>0.8)
2. Factor 1.0775 (µg/m³)/CPM should be applied for TSP monitoring

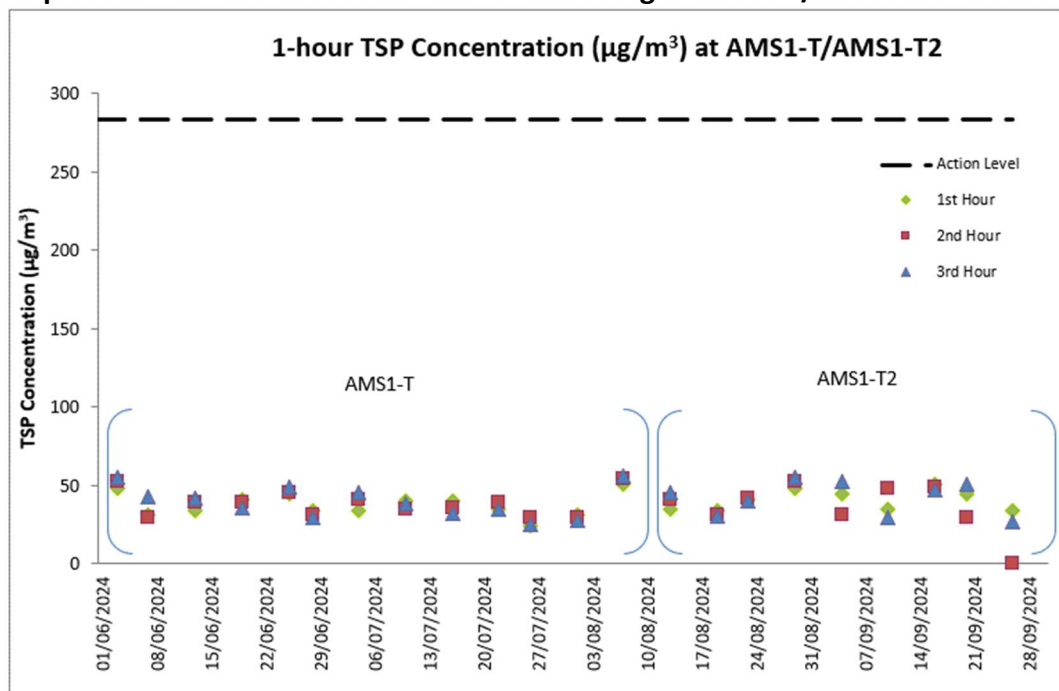
## Graphical Presentation for 1-hour TSP Monitoring at AMS1-T/AMS1-T2

During the reporting period, temporary monitoring station AMS1-T, was no longer accessible from 13 August 2024, due to the relocation of the Agriculture, Fisheries and Conservation Department Kowloon Animal Management Centre. Alternative temporary air quality monitoring station, AMS1-T2 was proposed by ET and agreed by IEC on 9 August 2024 and further approved by EPD on 28 August 2024 for conducting impact monitoring during the reporting period.

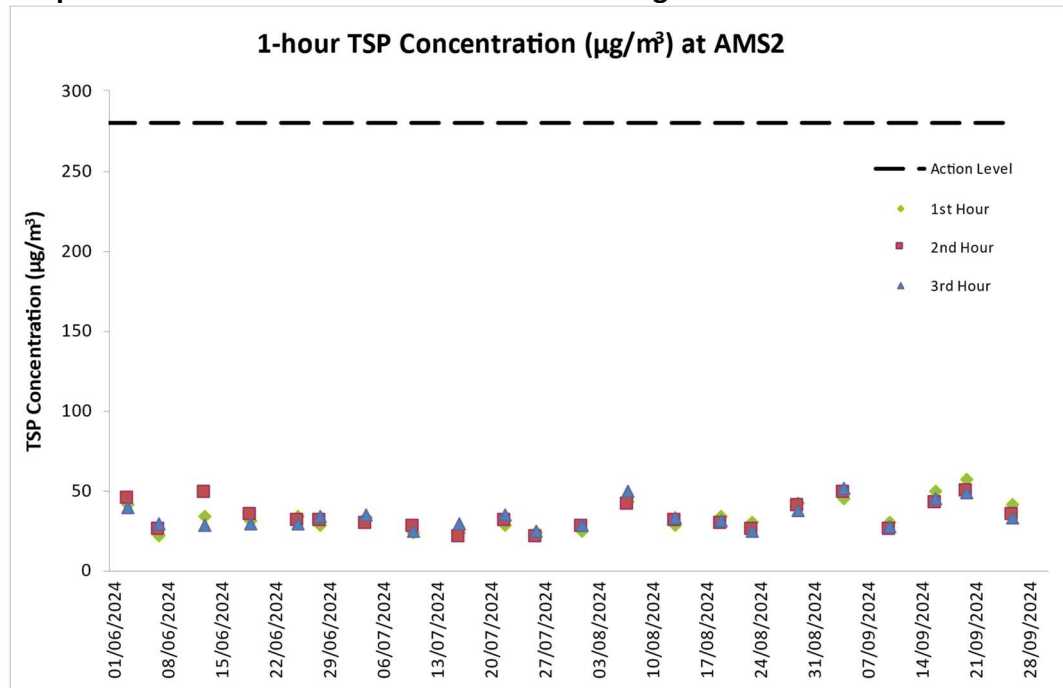
## Graphical Presentation for 1-hour TSP Monitoring at AMS2

Date	Start Time	Finish Time	Weather	Wind Speed (m/s)	Wind Direction (deg)	1-hour TSP ( $\mu\text{g}/\text{m}^3$ )
04-Sep-24	9:32	10:32	Fine	1.4	235	45
04-Sep-24	10:32	11:32	Fine	1.4	259	49
04-Sep-24	11:32	12:32	Fine	2.2	248	51
10-Sep-24	9:21	10:21	Sunny	3.3	116	30
10-Sep-24	10:21	11:21	Sunny	3.3	124	26
10-Sep-24	11:21	12:21	Sunny	4.2	120	27
16-Sep-24	9:20	10:20	Fine	2.8	110	50
16-Sep-24	10:20	11:20	Fine	1.1	variable	42
16-Sep-24	11:20	12:20	Fine	3.3	variable	45
20-Sep-24	8:40	9:40	Fine	2.8	117	57
20-Sep-24	9:40	10:40	Fine	2.8	29	50
20-Sep-24	10:40	11:40	Fine	2.5	149	49
26-Sep-24	9:08	10:08	Fine	2.2	311	41
26-Sep-24	10:08	11:08	Fine	1.4	253	35
26-Sep-24	11:08	12:08	Fine	2.2	276	33

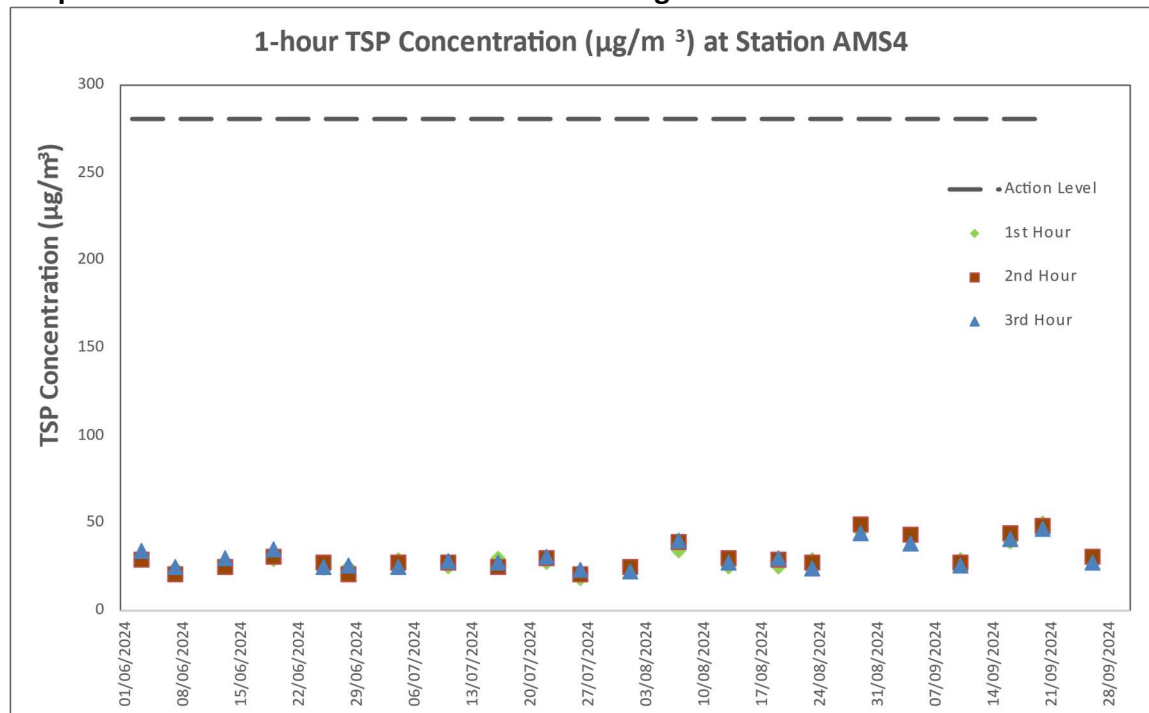
### Graphical Presentation for 1-hour TSP Monitoring at AMS4

Date	Start Time	Finish Time	Weather	Wind Speed (m/s)	Wind Direction (deg)	1-hour TSP ( $\mu\text{g}/\text{m}^3$ )
04-Sep-24	10:37	11:37	Fine	1.7	279	42
04-Sep-24	11:37	12:37	Fine	2.5	253	43
04-Sep-24	12:37	13:37	Fine	1.7	244	38
10-Sep-24	10:25	11:25	Sunny	3.3	118	29
10-Sep-24	11:25	12:25	Sunny	4.2	117	27
10-Sep-24	12:25	13:25	Sunny	2.8	109	26
16-Sep-24	10:25	11:25	Fine	1.4	119	39
16-Sep-24	11:25	12:25	Fine	3.1	65	44
16-Sep-24	12:25	13:25	Fine	2.5	141	41
20-Sep-24	9:13	10:13	Fine	3.3	133	50
20-Sep-24	10:13	11:13	Fine	3.3	127	48
20-Sep-24	11:13	12:13	Fine	3.9	122	47
26-Sep-24	10:50	11:50	Fine	1.4	261	29
26-Sep-24	11:50	12:50	Fine	3.3	273	31
26-Sep-24	12:50	13:50	Fine	3.6	281	27

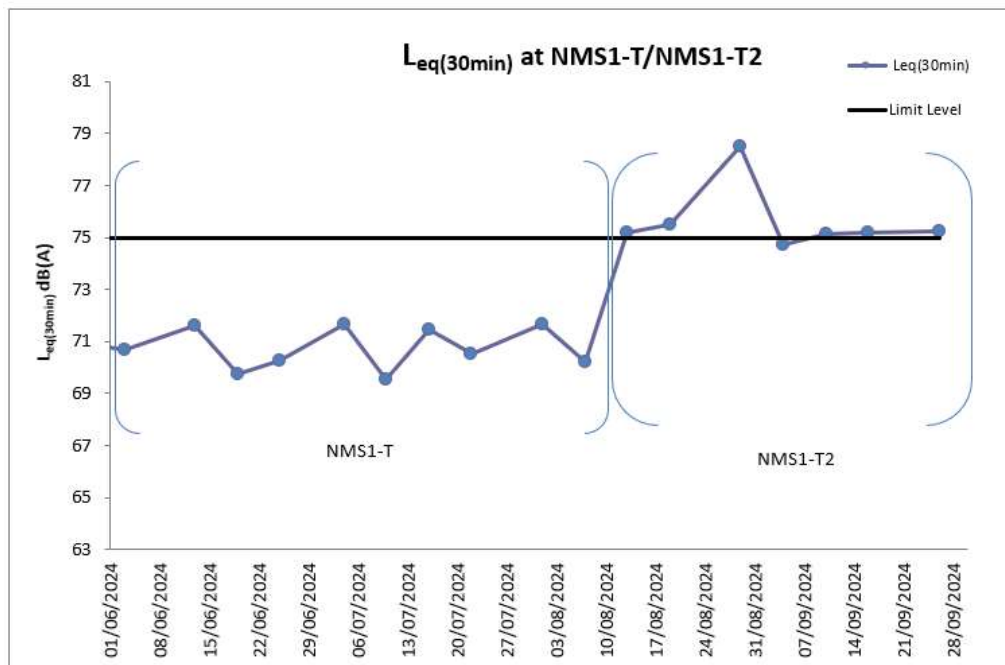
### Graphical Presentation for Noise Monitoring at NMS1-T/NMS1-T2

During the reporting period, temporary monitoring station NMS1-T, was no longer accessible from 13 August 2024, due to the relocation of the Agriculture, Fisheries and Conservation Department Kowloon Animal Management Centre. Alternative temporary noise monitoring station, NMS1-T2 was proposed by ET and agreed by IEC on 9 August 2024 and further approved by EPD on 28 August 2024 for conducting impact monitoring during the reporting period.

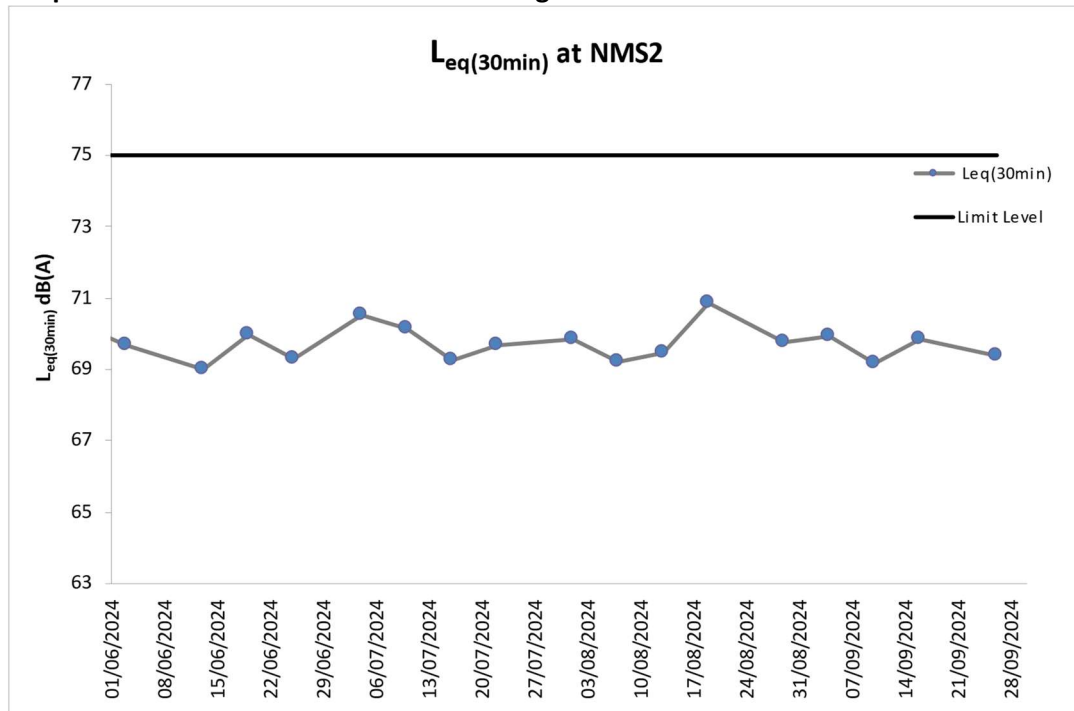
### Graphical Presentation for Noise Monitoring at NMS2

Date	Time	Weather	L <sub>eq</sub> (5min)	L <sub>10</sub>	L <sub>90</sub>	Measured L <sub>eq</sub> (30min)
04-Sep-24	09:35	Fine	70.1	73.7	66.3	69.9
04-Sep-24	09:40	Fine	69.2	72.0	65.9	
04-Sep-24	09:45	Fine	68.7	71.8	64.6	
04-Sep-24	09:50	Fine	69.4	72.5	65.7	
04-Sep-24	09:55	Fine	71.0	74.2	66.5	
04-Sep-24	10:00	Fine	70.7	73.6	66.0	69.2
10-Sep-24	09:24	Sunny	68.9	71.0	64.5	
10-Sep-24	09:29	Sunny	70.6	73.4	66.8	
10-Sep-24	09:34	Sunny	69.3	72.7	65.0	
10-Sep-24	09:39	Sunny	68.7	71.9	64.2	
10-Sep-24	09:44	Sunny	69.1	72.6	65.4	
10-Sep-24	09:49	Sunny	68.0	71.0	64.9	69.8
16-Sep-24	09:23	Fine	68.0	71.2	64.3	
16-Sep-24	09:28	Fine	69.7	72.0	65.8	
16-Sep-24	09:33	Fine	70.1	73.4	66.0	
16-Sep-24	09:38	Fine	69.4	72.5	65.9	
16-Sep-24	09:43	Fine	70.8	73.7	66.6	
16-Sep-24	09:48	Fine	70.5	73.9	66.1	69.4
26-Sep-24	09:06	Fine	68.3	71.0	63.3	
26-Sep-24	09:11	Fine	69.6	72.2	64.9	
26-Sep-24	09:16	Fine	68.7	70.3	65.9	
26-Sep-24	09:21	Fine	69.1	71.9	64.9

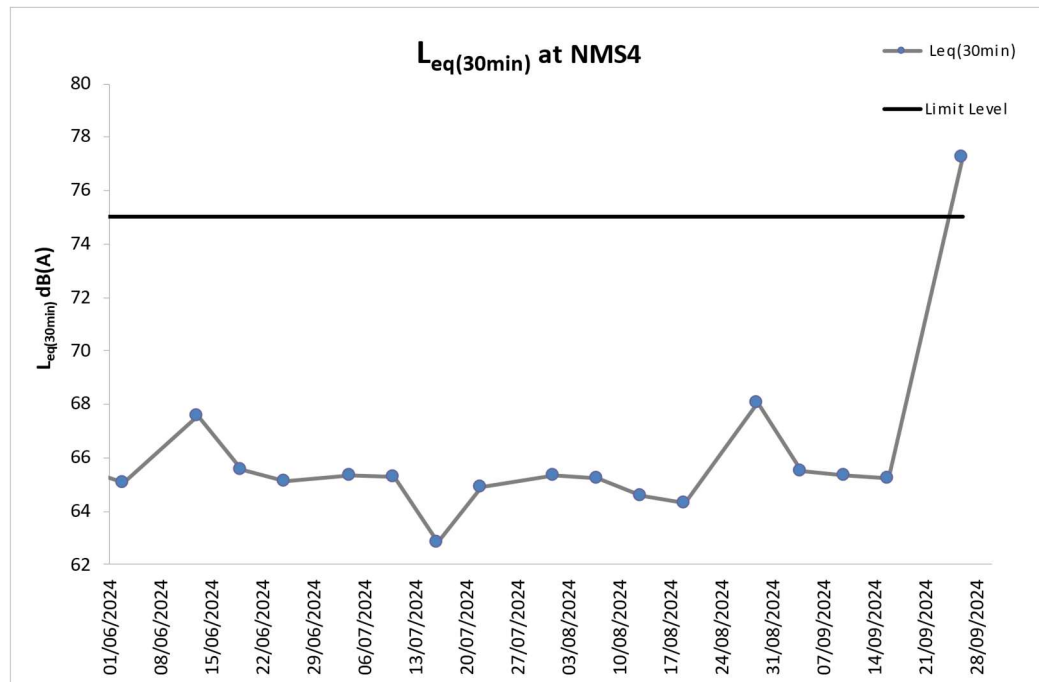
### Graphical Presentation for Noise Monitoring at NMS4

Date	Time	Weather	L <sub>eq(5min)</sub>	L <sub>10</sub>	L <sub>90</sub>	Measured L <sub>eq(30min)</sub>
04-Sep-24	09:35	Fine	65.1	67.9	63.2	
04-Sep-24	09:40	Fine	64.9	66.0	62.5	
04-Sep-24	09:45	Fine	66.3	68.4	64.8	65.5
04-Sep-24	09:50	Fine	66.6	68.7	64.7	
04-Sep-24	09:55	Fine	64.0	66.5	62.6	
04-Sep-24	10:00	Fine	65.5	67.4	63.0	
10-Sep-24	09:24	Sunny	65.0	67.7	63.8	
10-Sep-24	09:29	Sunny	66.3	68.4	64.5	
10-Sep-24	09:34	Sunny	64.6	66.9	62.2	65.4
10-Sep-24	09:39	Sunny	65.9	67.6	63.0	
10-Sep-24	09:44	Sunny	64.1	66.0	62.1	
10-Sep-24	09:49	Sunny	65.8	67.2	63.7	
16-Sep-24	09:23	Fine	64.1	66.5	62.3	
16-Sep-24	09:28	Fine	65.9	67.0	63.6	
16-Sep-24	09:33	Fine	65.7	67.2	63.6	65.2
16-Sep-24	09:38	Fine	66.4	68.1	64.0	
16-Sep-24	09:43	Fine	64.6	66.7	62.9	
16-Sep-24	09:48	Fine	64.0	66.8	62.5	
26-Sep-24	09:06	Fine	74.6	77.5	63.8	
26-Sep-24	09:11	Fine	78.7	83.6	64.9	
26-Sep-24	09:16	Fine	78.4	83.2	63.2	77.2
26-Sep-24	09:21	Fine	65.3	67.3	62.1

26-Sep-24	09:26	Fine	76.7	82.4	62.9	
26-Sep-24	09:31	Fine	79.8	84.2	65.1

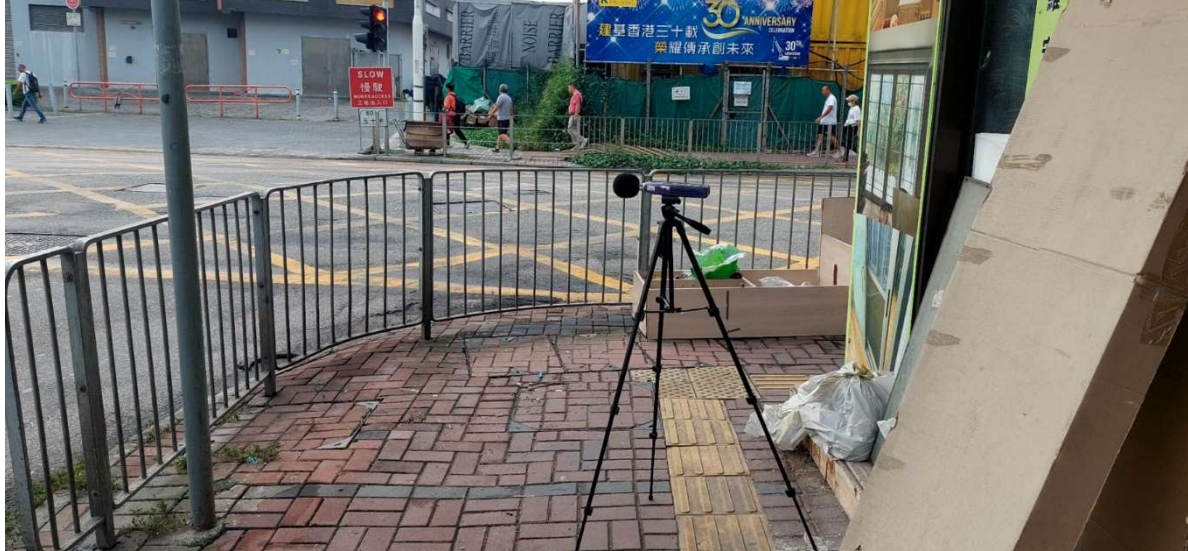
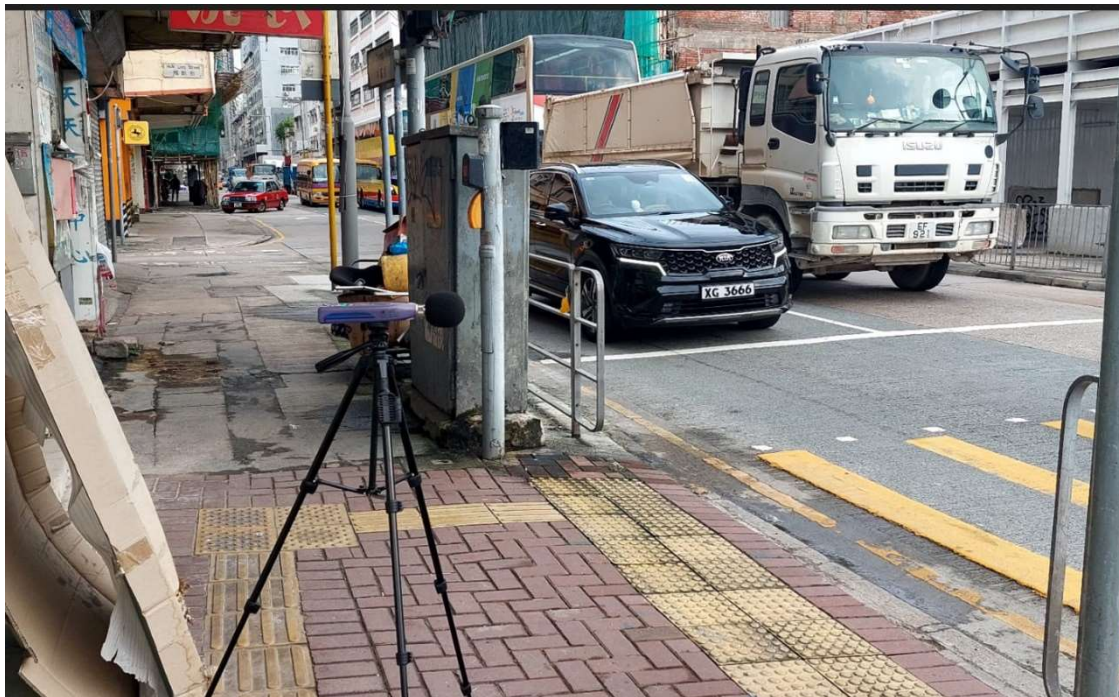
**Photo 1a and 1b:** Nearby road traffic along Mok Cheong Street at NMS1-T2 on 10 September 2024.

**Photo 2:** Power Mechanical Equipment with Quality Power Mechanical Equipment (QPME) labels were used at site to lower the noise nuisance to the nearby residents.

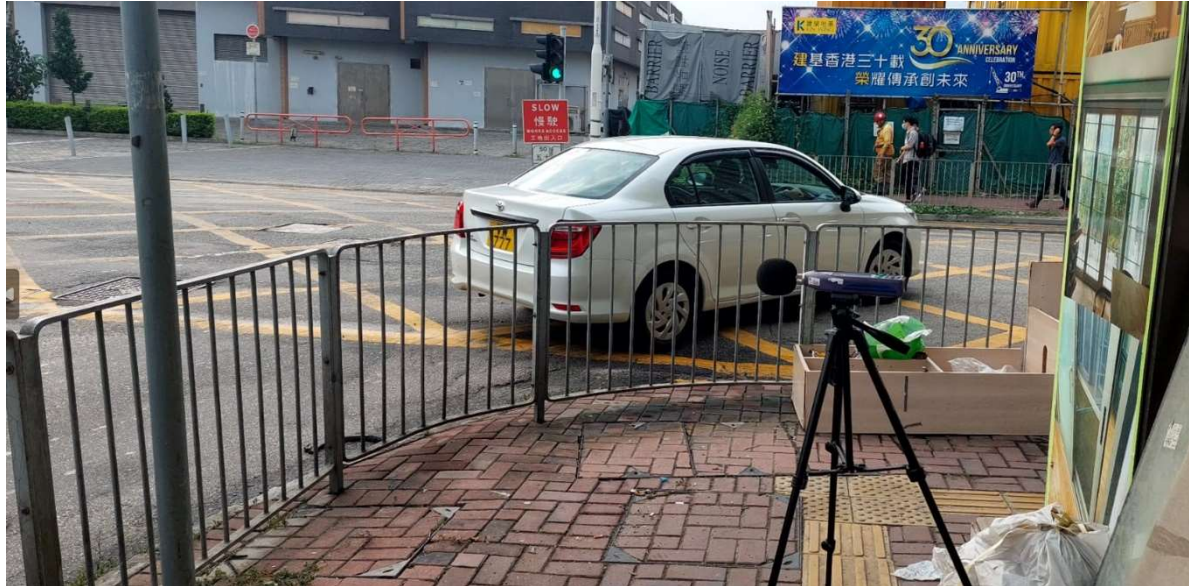
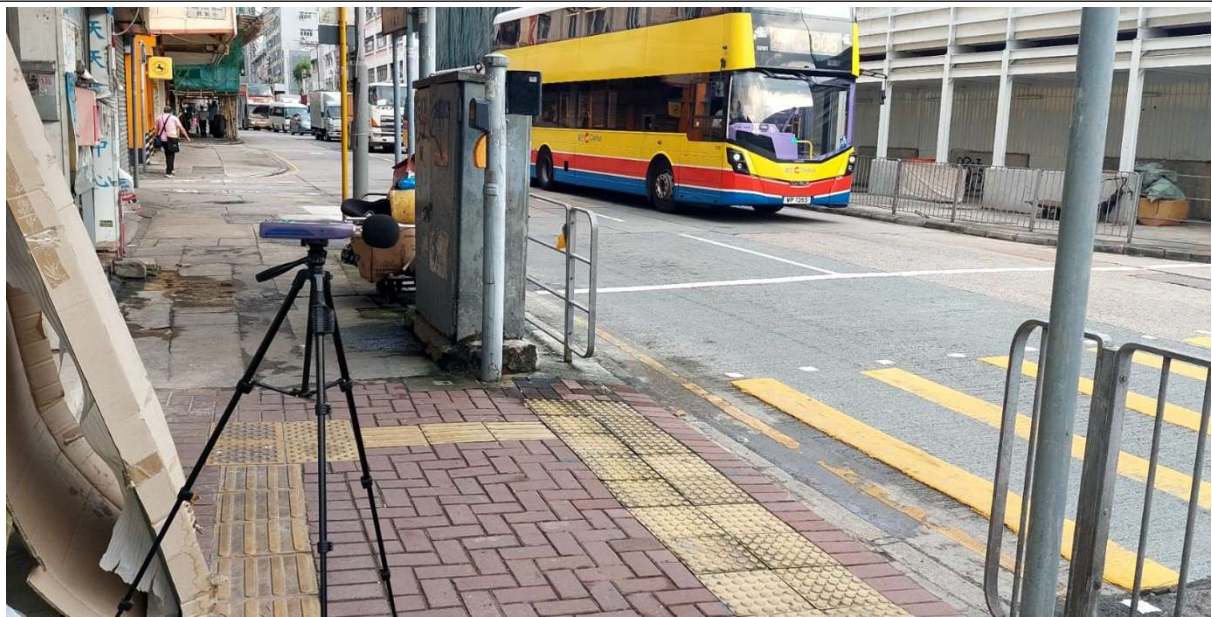
**Photo 1a and 1b:** Nearby road traffic noise along Mok Cheong Street and To Kwa Wan Road at NMS1-T2 on 16 September 2024.

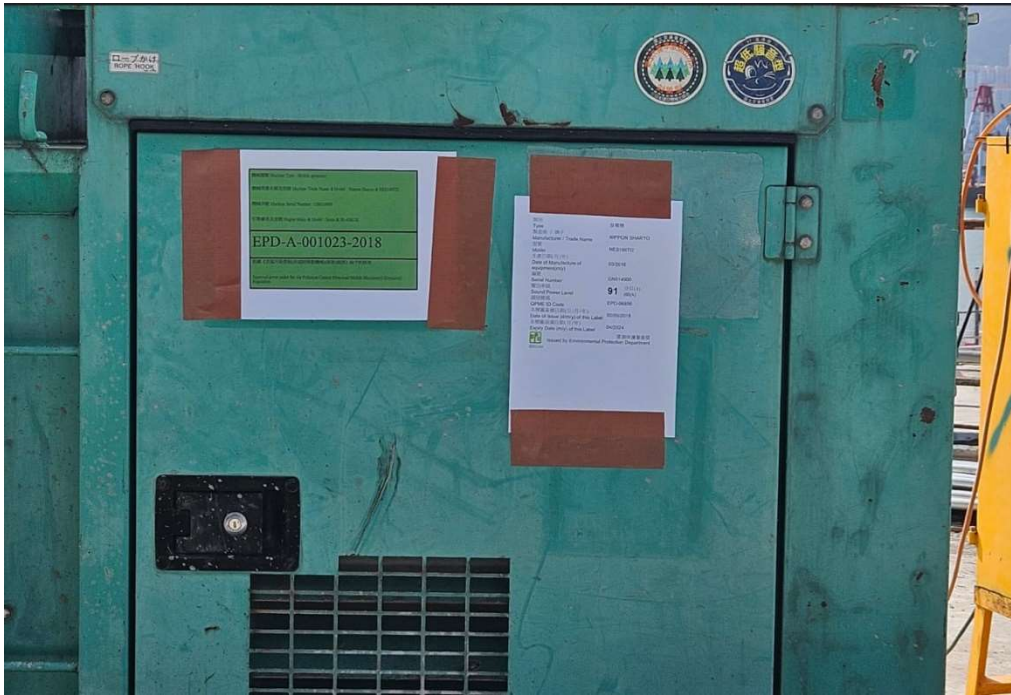
**Photo 2:** Power Mechanical Equipment with Quality Power Mechanical Equipment (QPME) labels were used at site to lower the noise nuisance to the nearby residents.

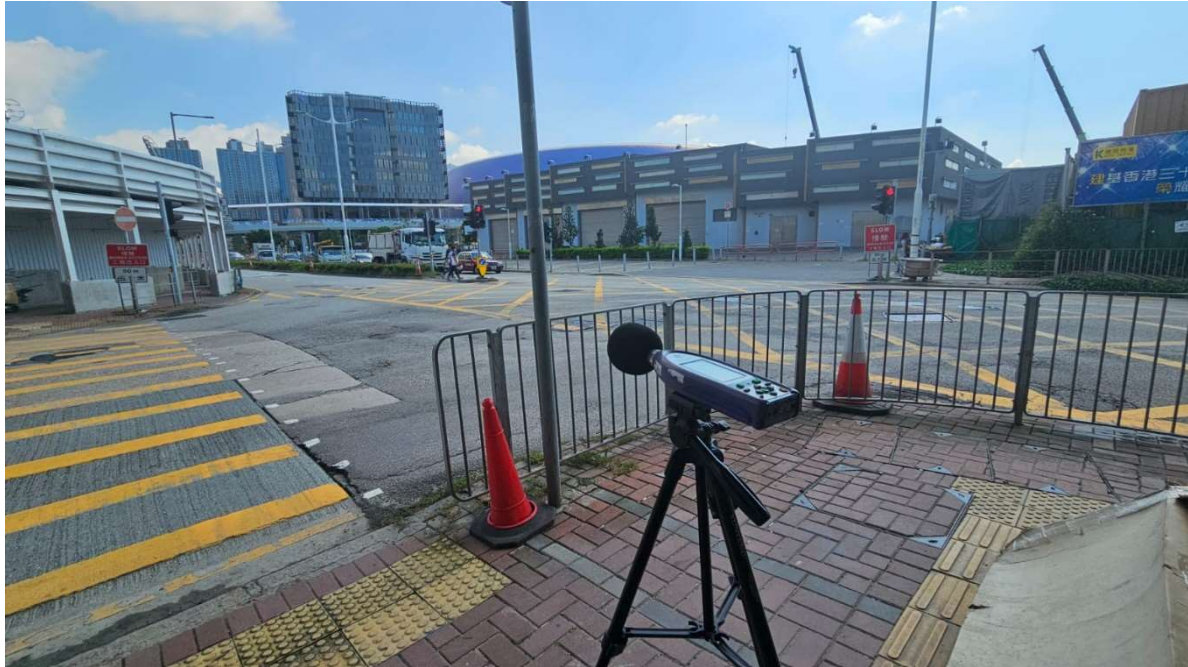
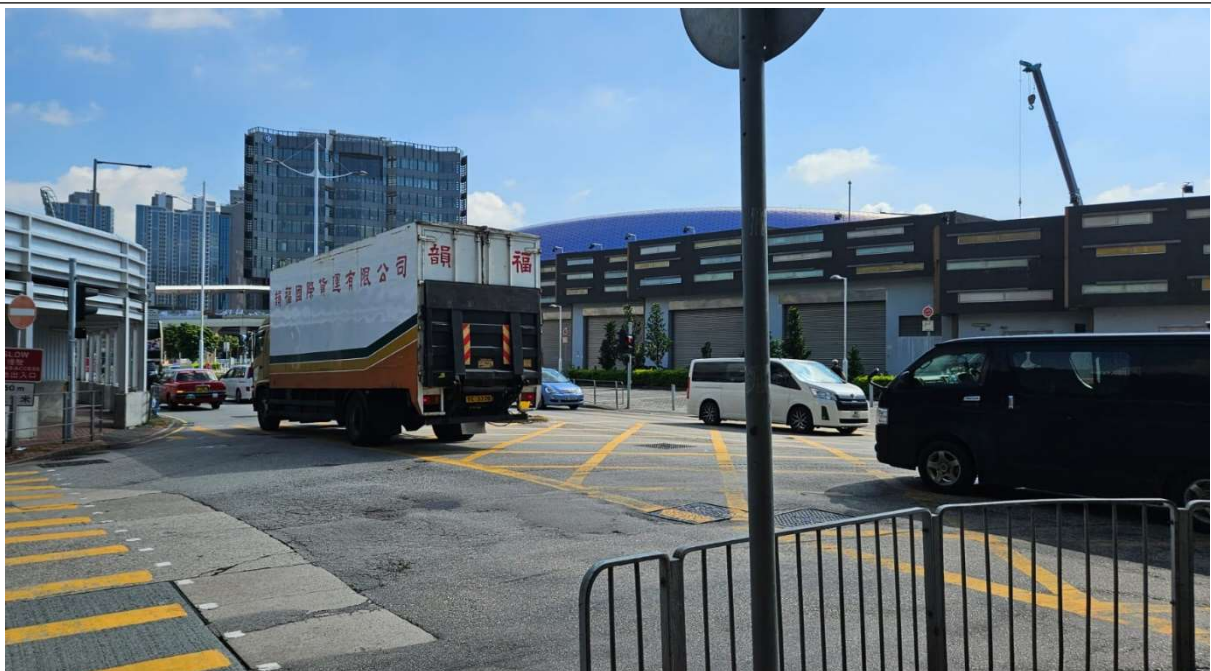
**Photo 1a and 1b:** Nearby road traffic along To Kwa Wan Road at NMS1-T2 on 26 September 2024.

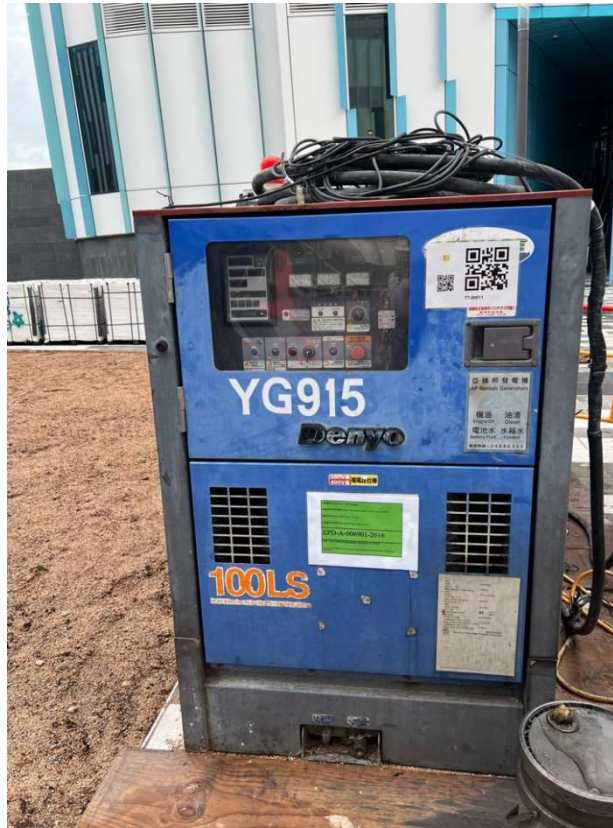
**Photo 2:** Power Mechanical Equipment with Quality Power Mechanical Equipment (QPME) labels were used at site to lower the noise nuisance to the nearby residents.

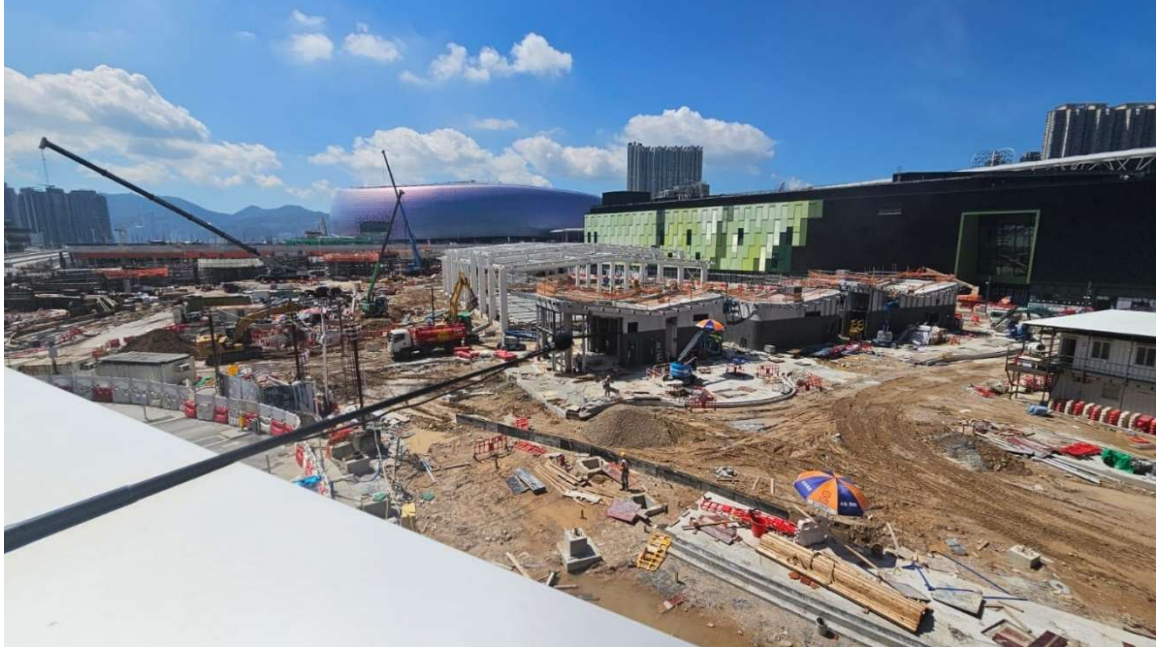
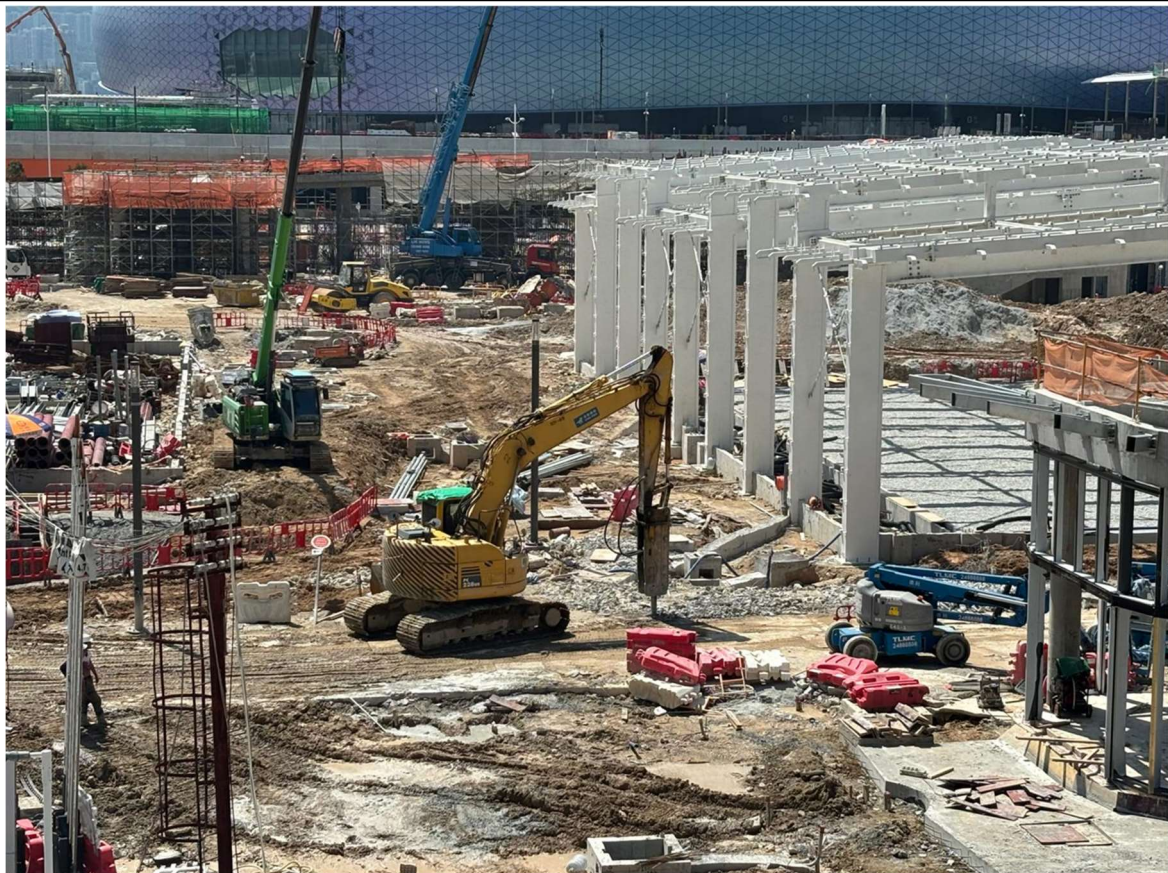
**Photo 1a and 1b:** Ground breaking work was observed within Kai Tak Sports Park area on 26 September 2024.

**Photo 3:** Noise acoustic wrapping has been provided for the breaker to reduce noise emission from the breaking work.

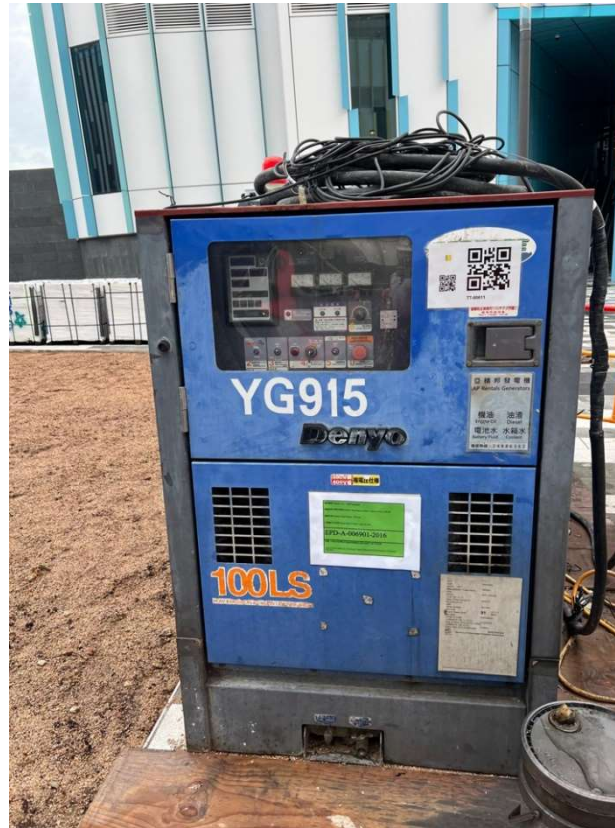
**Photo 2:** Power Mechanical Equipment with Quality Power Mechanical Equipment (QPME) labels were used at site to lower the noise nuisance to the nearby residents.

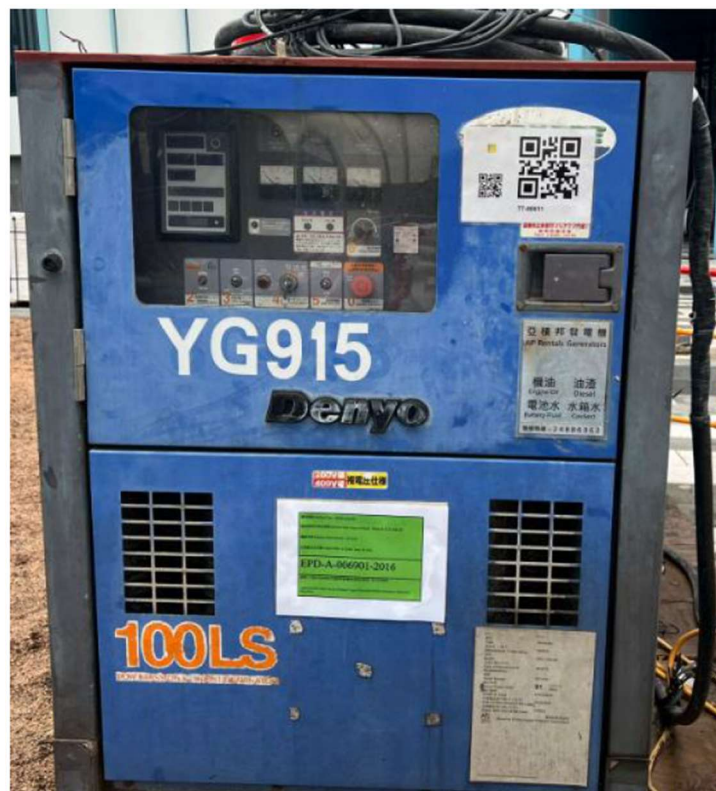
**Photo 2 :** Power Mechanical Equipment with Quality Power Mechanical Equipment (QPME) labels were used at site to lower the noise nuisance to the nearby residents.

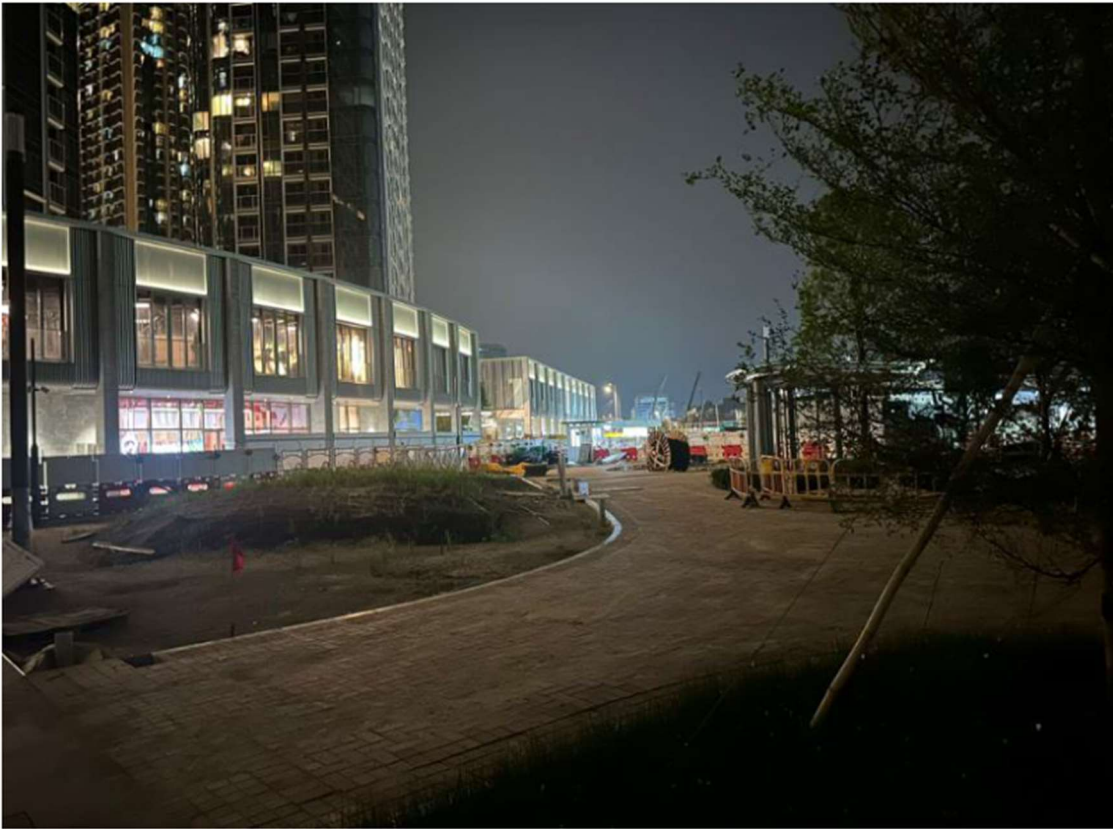
**Photo 5:** Night time inspections were conducted to ensure all Power Mechanical Equipment were switched off.
