Agreement No. CE 30/2018 (EP) Environmental Team for Kai Tak Sports Park – Design and Construction

Quarterly EM&A Report (Jul 2023 - Sep 2023)

Kai Tak Sports Park - Investigation

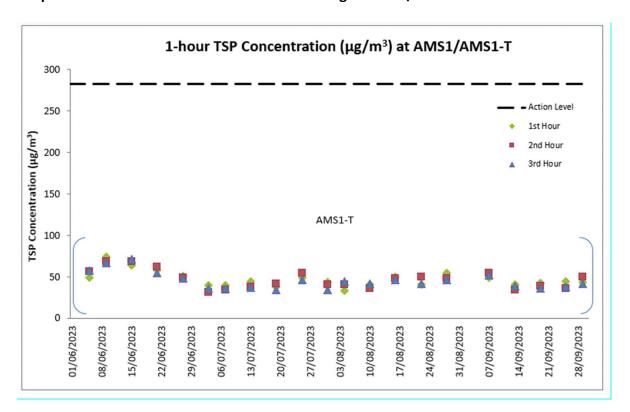
Graphical Presentation for 1-hour TSP Monitoring at AMS1/AMS1-T

*Note: During the reporting period, monitoring station AMS1 was no longer open for monitoring from September 2022, due to relocation of the Hong Kong Society for the Blind Workshop. Temporary air quality monitoring station, AMS1-T was used to conduct dust monitoring in September 2022. Details of temporary alternative monitoring locations are presented in Temporary Alternative Proposal for Monitoring Station as proposed by ET and agreed by IEC dated 6 January 2021.

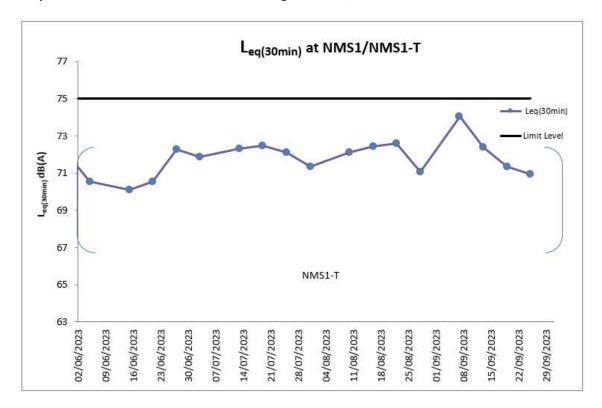
Graphical Presentation for Noise Monitoring at NMS1/NMS1-T

Temporary noise monitoring station, NMS1-T was used to conduct noise monitoring in September 2022. Details of temporary alternative monitoring locations are presented in Temporary Alternative Proposal for Monitoring Station as proposed by ET and agreed by IEC dated 6 January 2021.

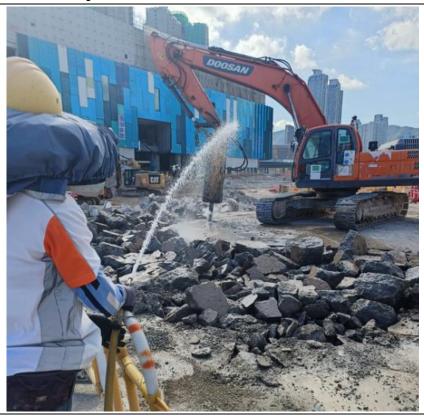
According to the contractor information, ground breaking was found in the area near N4 gate. Dust suppression measures had been properly implemented during ground breaking works. (Photo 1). Further enhancement had been carried out to prevent possible environmental nuisance included:

Photo 1: Water spraying had been implemented during ground breaking works.

- 1. Dust suppression measures (i.e. Water spraying) had been implemented during ground breaking works (Photo 1).
- 2. Water truck had been working continuously around all haul road within the site (Photo 2).
- 3. Water misting cannon had been installed to wet the area which water trucks cannot reach (Photo 3).
- 4. Implementation of construction dust mitigation measures recommended in EIA's Environmental Mitigation Implementation Schedule.

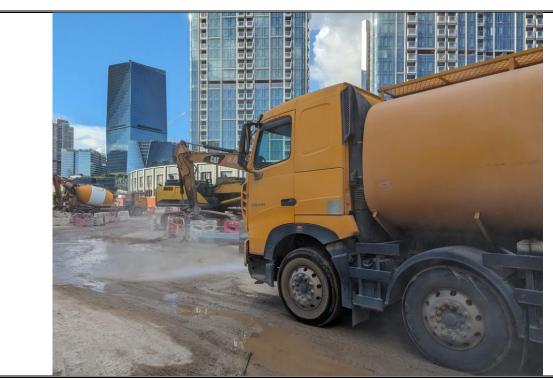
Photo 2: Water truck had been working continuously around all haul road within the site.

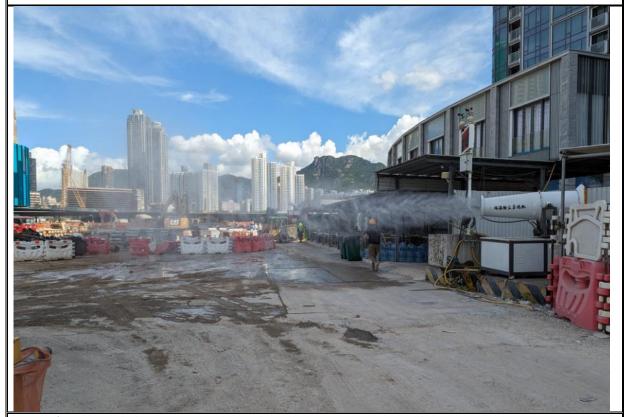
Photo 3: Water misting cannon had been installed to wet the area which water trucks cannot reach.

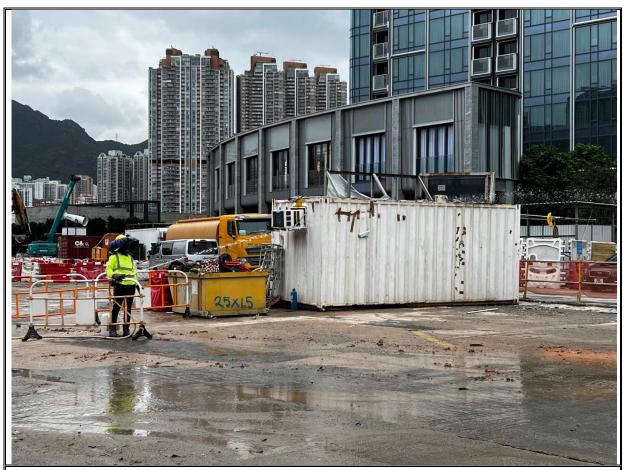
ET and contractor carried out regular site inspections at Kai Tak Sports Park on 19 July 2023. (Photo 4) Construction dust mitigation measures recommended in EIA's Environmental Mitigation Implementation Schedule were generally implemented during the time of inspection.

Photo 4: Water spraying was observed during regular site inspection on 19 July 2023. (site area at POS N(E))

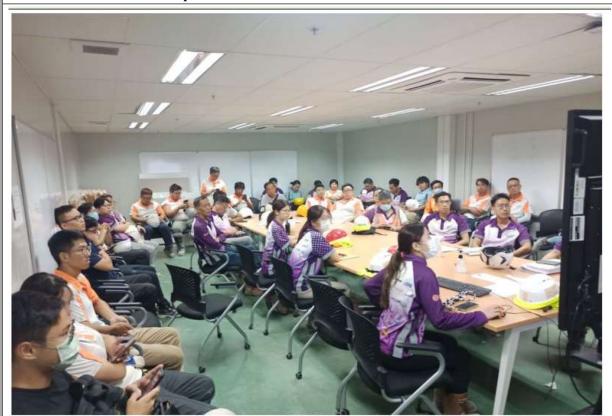
Photo 1: All subcontractors are reminded to read and follow the latest Construction Noise Permit Requirement..
